DESIGN AND INSTALLATION
OF WALLS & CEILINGS
IN TALL BUILDINGS

DESIGN AND INSTALLATION OF WALLS & CEILINGS IN TALL BUILDINGS

INTRODUCTION

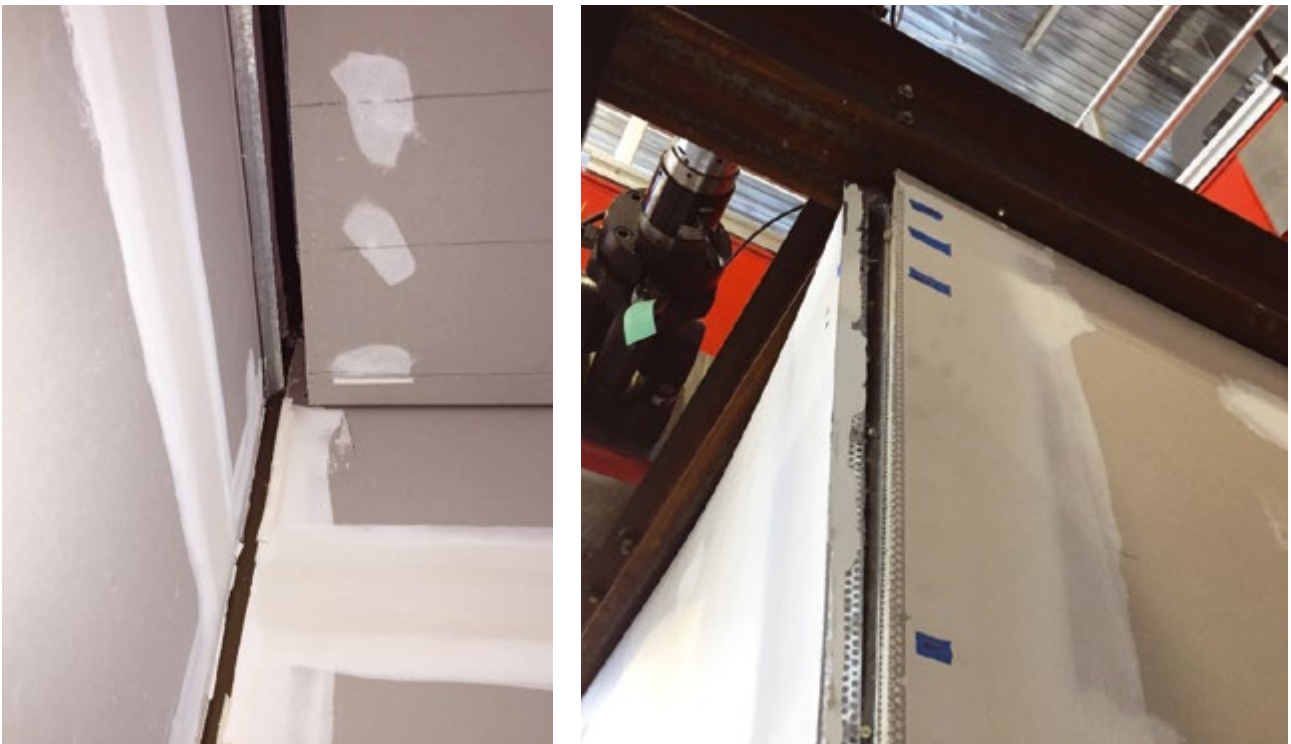
■ PHOTOS 6 & 7 – 1.5% DRIFT (40.5MM) INTERNAL CORNER, CEILING JUNCTION AND EXTERNAL CORNER

Between the L/360 (5.40mm) and 1.5% drift limits the damage to the wall and ceiling systems propagates and photos 6 and 7 show the extent of damage at the 1.5% drift limit. This level of damage and separation, whilst not resulting in loss of stability, would be quite disconcerting to any occupant of the building and would present significant issues for maintaining operational functionality for any services crossing these building elements.

Considering the New Zealand serviceability limits it appears SLS2 could be satisfied at approximately L/240 drift limits, noting that patch and paint repairs would be necessary however the expected damage would not require immediate repair and these could be scheduled with other works as appropriate.

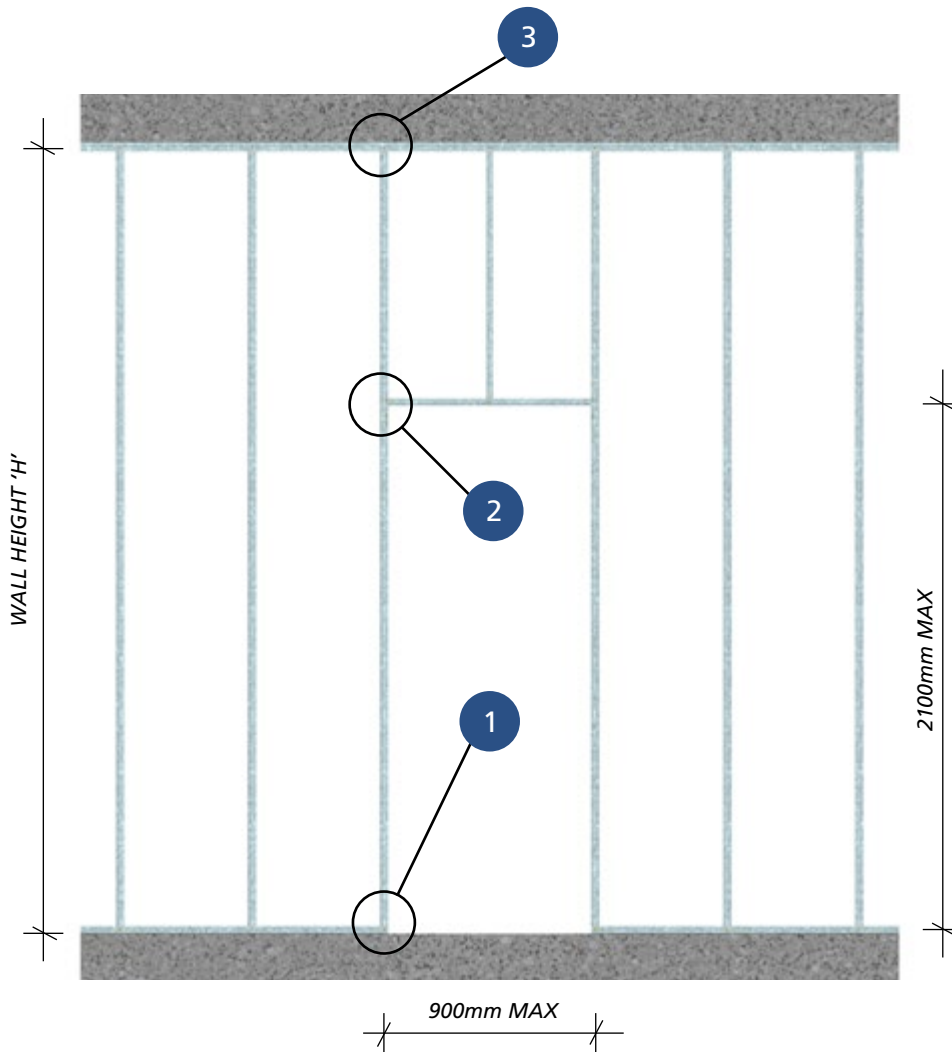
■ DOOR OPENING
